SB2/2023

AUGUST 2023

**Potential failure of
Deutsche Schlauchboot GmbH (DSB) liferafts
serviced by Comfer Marin SL, Marin, Spain
identified following the foundering of the fishing vessel
Piedras (FD 528)
south-west of Mizen Head, the Republic of Ireland
on 1 June 2022**

MAIB SAFETY BULLETIN 2/2023

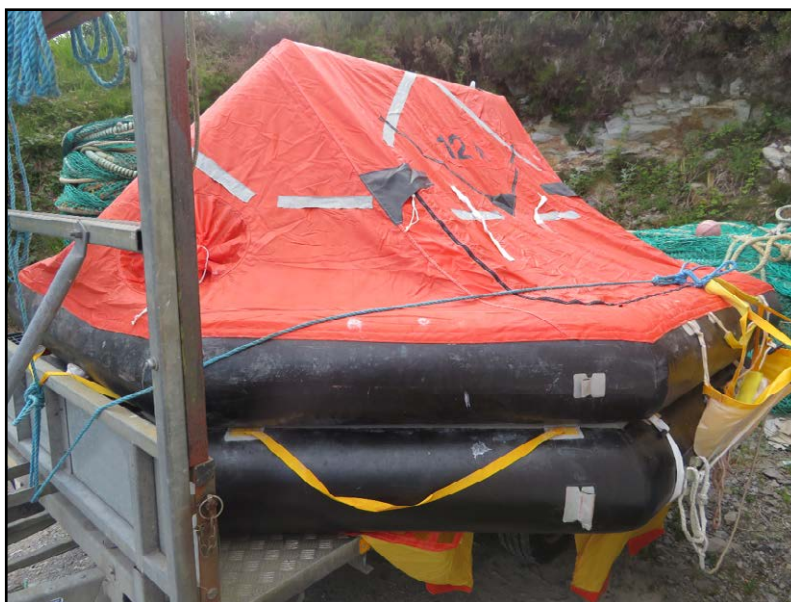
Recovered *Piedras* starboard liferaft

The starboard liferaft had not been correctly serviced since its manufacture in March 2007, despite having been routinely certified by Comfer Marin SL.

S2023/104M Immediately contact their nearest approved Survitec liferaft service station to arrange for the liferafts to be urgently reinspected and serviced to ensure they are fully functional and comply with statutory requirements.

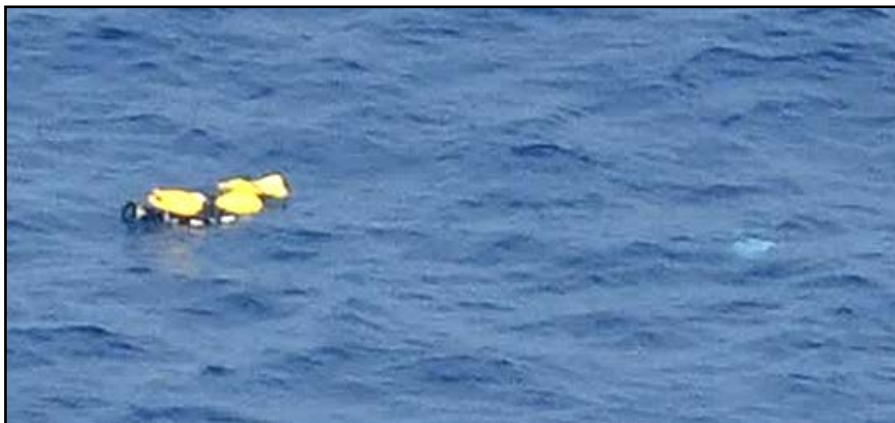
It was not possible to determine the cause of the port liferaft's failure to deploy correctly, as it was not recovered after the accident. It was last observed drifting in an inverted orientation, having apparently released from its canister and partially inflated (**Figure 1**).

Figure 1: The port liferaft, floating inverted and partially inflated

- Both of the liferafts carried by *Piedras* exhibited deficiencies that were sufficient to raise concerns relating to their servicing and certification; it is likely that these deficiencies contributed to the failure of the port liferaft to function correctly during the abandonment of the vessel.
- There is a risk that DSB liferafts certified by the service station Comfer Marin SL in Marin, Spain might not function correctly when deployed.

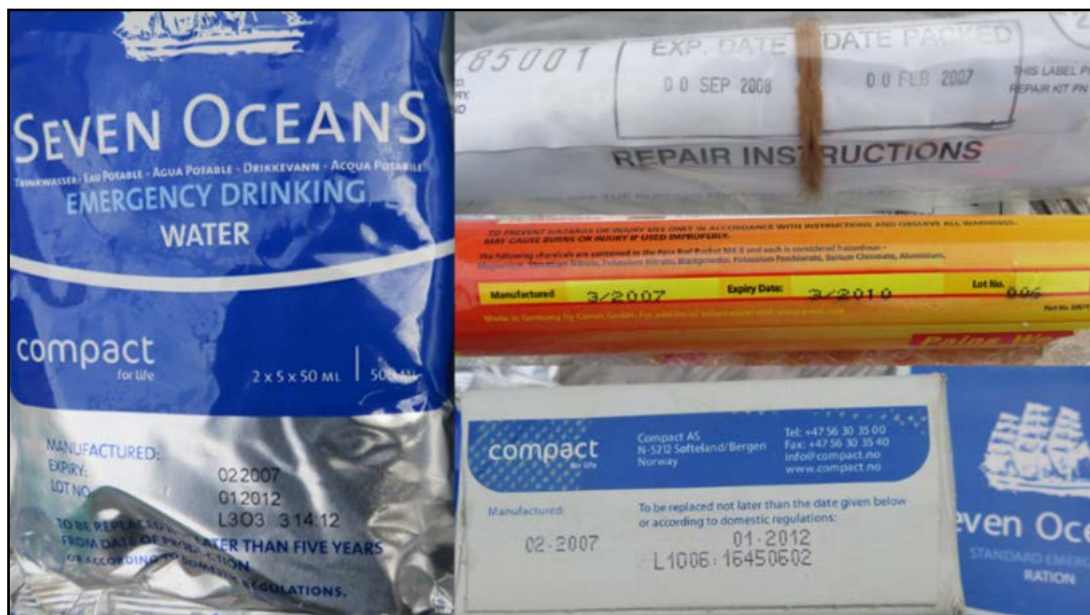
Subsequent examination by the MAIB of the SOLAS A³ pack in the recovered starboard liferaft (**Figure 2**) found that:

- the first aid kit had not been replaced since it was supplied in 2007;
- the liferaft repair kit had expired in September 2008;

- the torch batteries had expired in January 2010;
- all of the pyrotechnics had expired in March 2010; and
- all of the food and water supplies had expired in January 2012.

Figure 2: Examples of the expired consumable items in *Piedras's* starboard liferaft
